**INSPECTOR GROUP**

# Pre-Purchase Building & Timber Pest Inspection

**Sample Street 1234**

15 July 2026

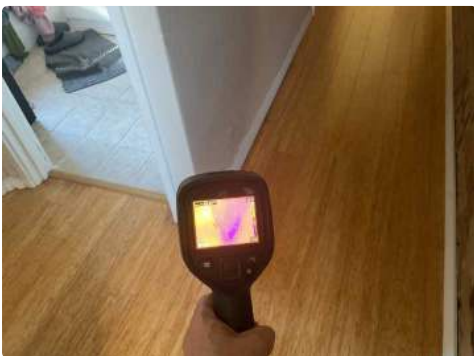
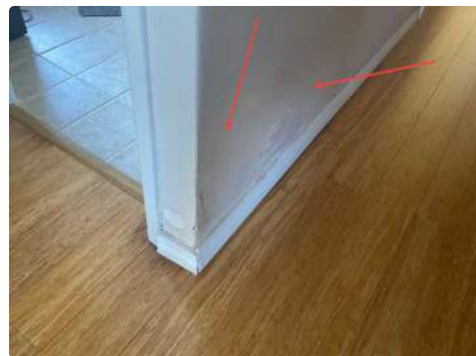
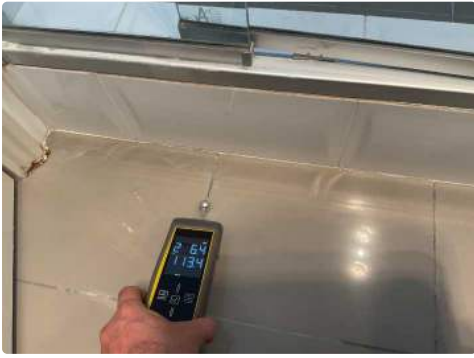
High moisture readings were found to the adjacent wall of the shower recess. It was also noticed when the thermal imaging camera was used that there was retained water inside a wall which could be possibly related to a plumbing leak. Recommend further investigations by a plumber.

Engage a suitably qualified tradesperson to investigate and carry out repairs.

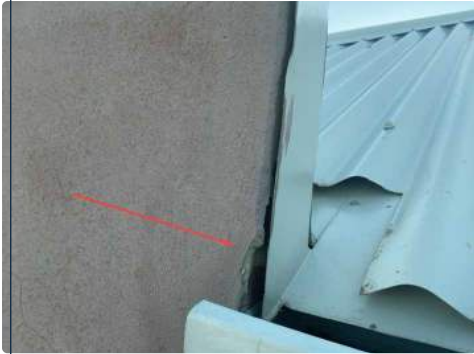
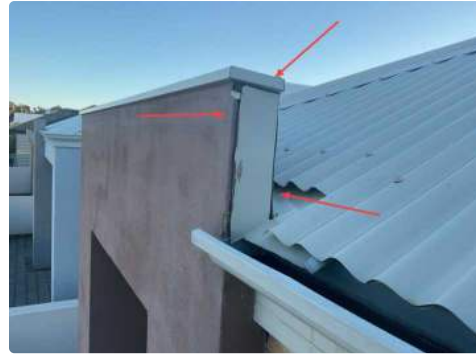
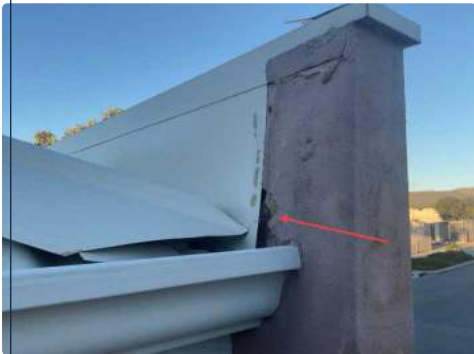
South Elevation

The roof flashings are currently incomplete and do not provide adequate coverage to prevent water ingress into the wall cavity and render. This deficiency is likely the result of poor installation practices or a failure to finish the roofing works to a trade-compliant standard. A licensed roof plumber must be engaged to complete the installation and ensure all flashings are properly integrated to maintain the building's watertight integrity.

**Engage a suitably qualified tradesperson to investigate and carry out repairs.**

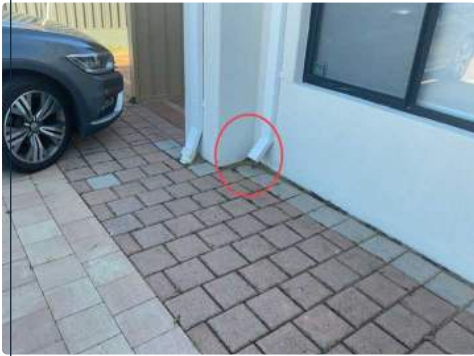
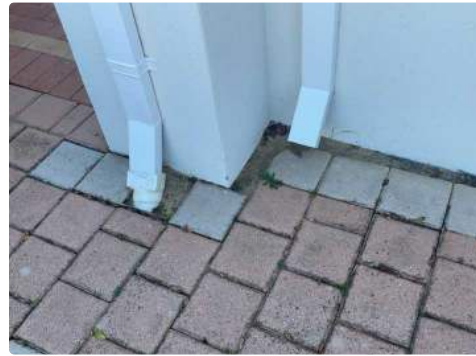
South Elevation

The roof downpipe is currently not connected to the stormwater system as required, resulting in a failure to properly discharge rainwater away from the building. This disconnect appears to be a result of incomplete installation or a lack of connection to the existing stormwater drainage, which may lead to localised saturation of the footings. A licensed roof plumber should be engaged to further investigate the drainage layout and ensure the downpipe is professionally connected to the designated stormwater drainage.

Downpipes not connected was observed and may create conditions conducive to timber pest activity.

Engage a suitably qualified tradesperson to investigate and carry out repairs.

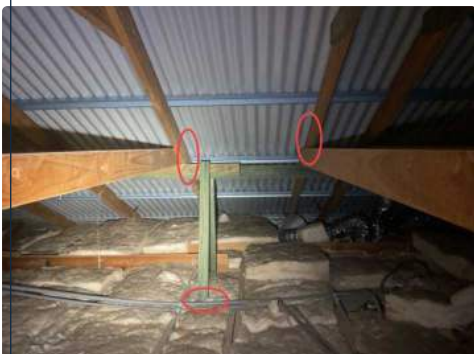
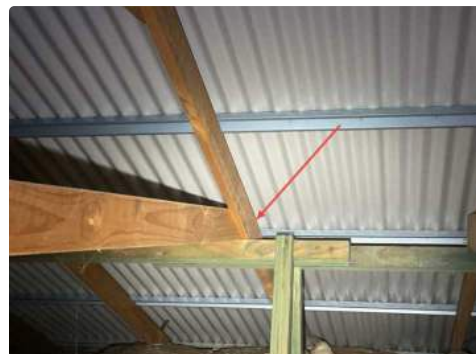
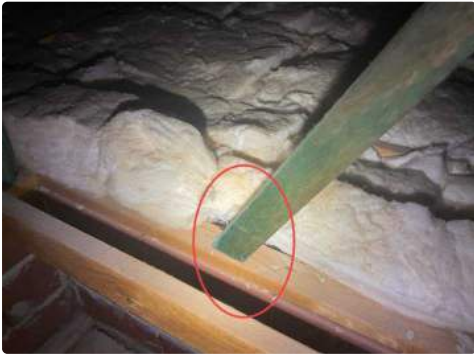
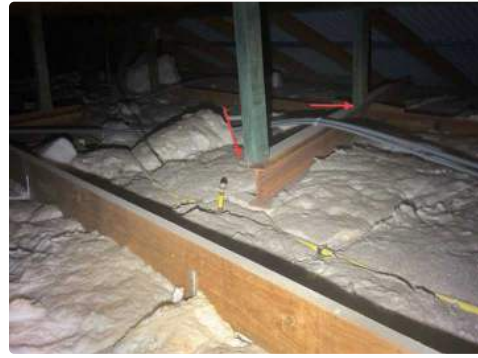
The roof void contains missing tie downs at critical junctions, specifically from the rafters to the underpurlins, underpurlins to the roof struts, and where struts meet the top wall plates and steel beams. These missing connections represent a failure to adequately secure the structural framing members. A licensed roof carpenter should be engaged to investigate the extent of the missing tie downs and perform all necessary structural rectifications.

Engage a qualified person to evaluate and repair as required.
